RE: Former Pinewood Hazardous Waste Disposal Facility  
Sumter County, South Carolina  
EPA ID Number: SCD 070 375 985

EPA CEI Pictures – February 22, 2016

CEI Report – Attachment 2

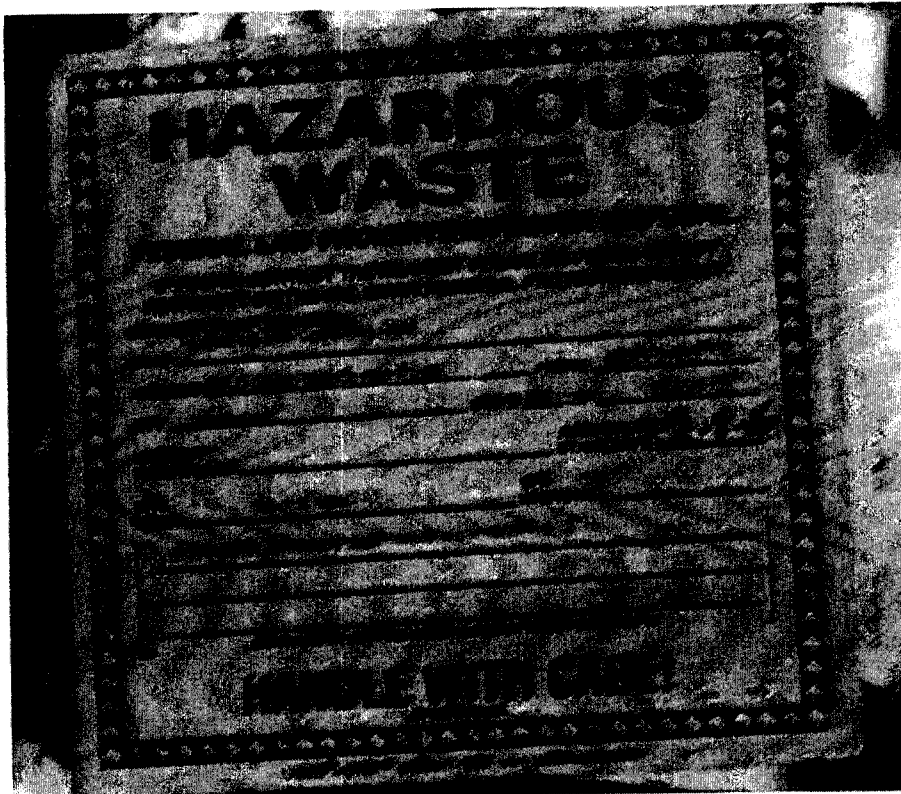
Picture 9: Close-up of the hazardous waste label on Tank #7 in the CTF. Picture taken by Javier García on 2/22/2016, at 2:13 pm.

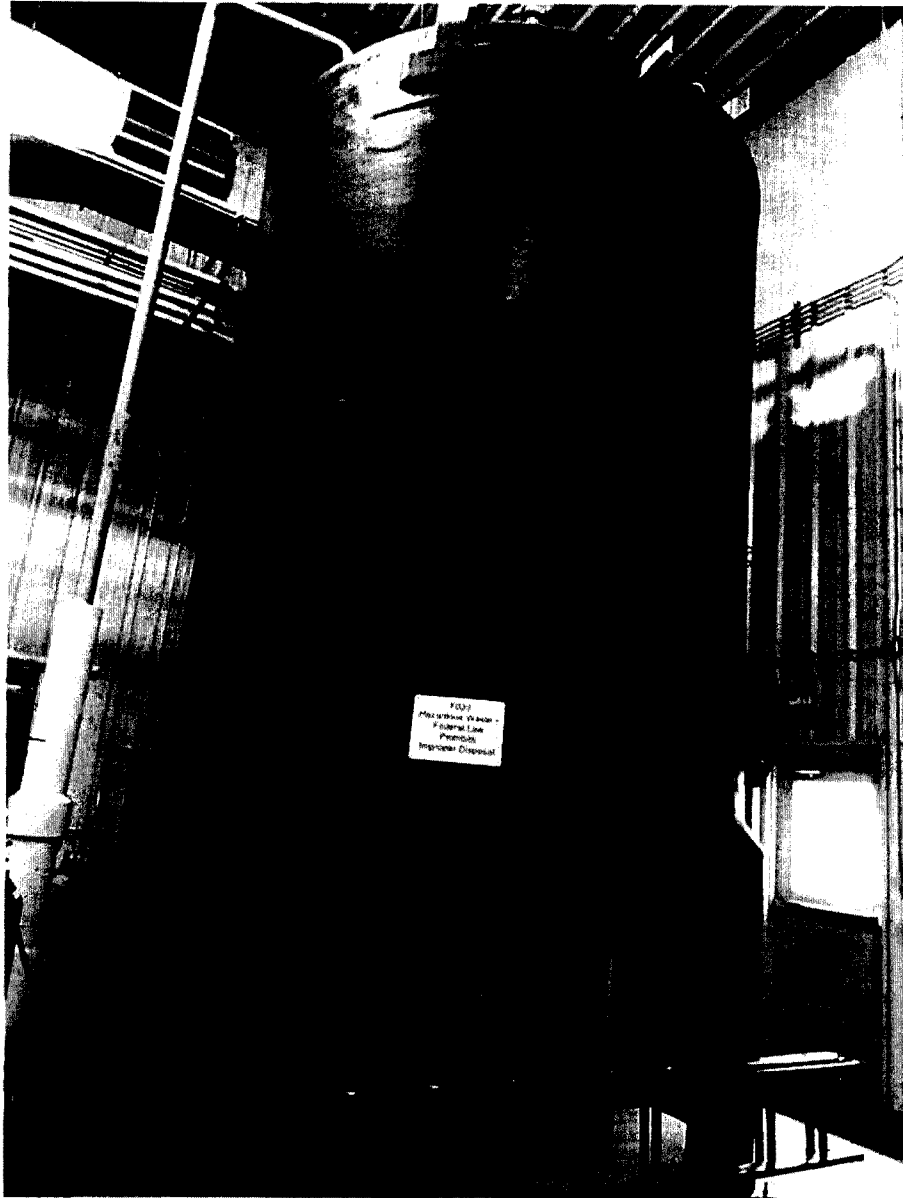
At the time of the inspection, all LTS units were properly identified and appeared to be in good condition (pictures 22 and 23). According to the facility's air permit application, all LTS units are vented directly to atmosphere via a common stack in the LTS building. Although the LTS has an air permit, the EPA recommends that the LTS be included in the Post Closure Care Permit as a Miscellaneous Unit (Subpart X) under of S.C. Code Ann. Regs. 61-79.264 [Subpart X of 40 C.F.R. Part 264 (40 C.F.R. Part 264)], and subject to Subpart CC of S.C. Code Ann. Regs. 61-79.265 [Subpart CC of 40 C.F.R. Part 265] or that it meets any of the exemptions in S.C. Code Ann. Regs. 61-79.265.1080(b) [40 C.F.R. § 265.1080(b)]. After the inspection, EPA personnel were informed that the RCRA post closure permit would be amended to include the LTS and the LTS sludge storage area.

Picture 23: Side view of Tank # 210 of the LTS. The tanks receives the flocculated leachate from tank 200 and it is used as the feed tank to the filter press. The tank is marked as containing hazardous wastes. Picture taken by Javier García on 2/22/2016, at 2:28 pm.

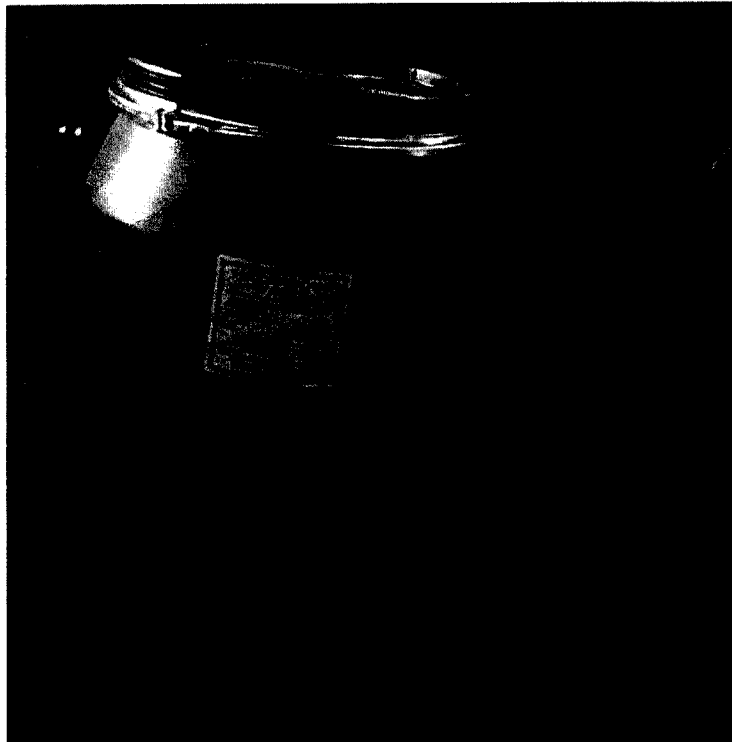
Picture 28: Non-burnable contaminated debris SAA container in the Waste Pile Building. Picture taken by Javier García on 2/22/2016, at 3:17 pm.

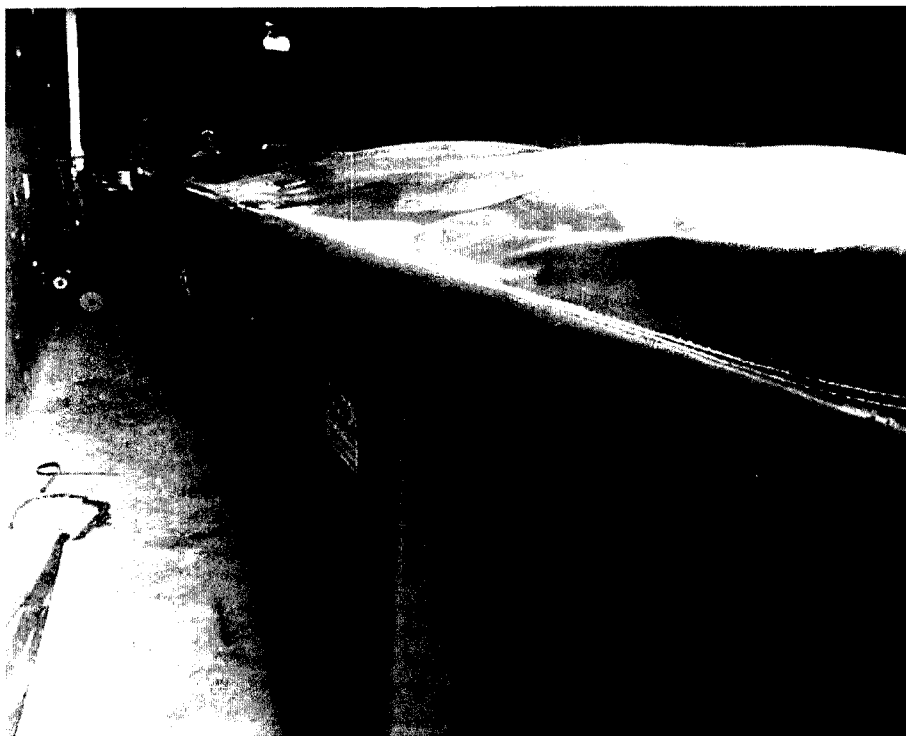
Picture 32: General view of the filter press sludge roll-off container in the Waste Pile Building. The container was marked with the accumulation start date of 9/12/15. Picture taken by Javier García on 2/22/2016, at 3:19 pm.

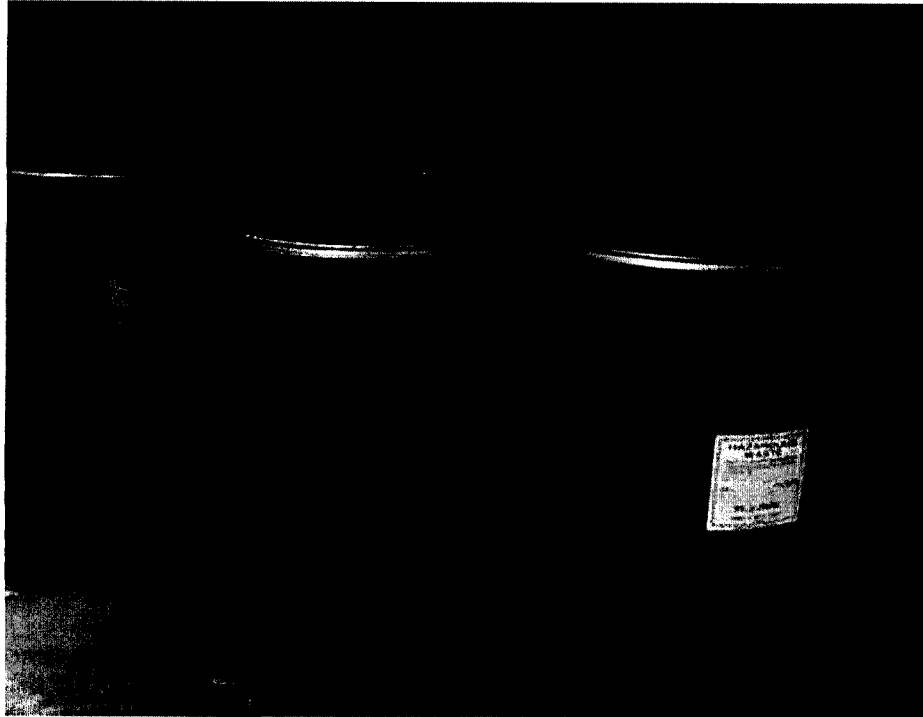
Across from the roll-off container, along the building wall, the inspectors observed ten 55-gallon containers (pictures 33 and 34). The containers were reported to contain hazardous waste contaminated debris (burnable and non-burnable). The containers were properly labeled, dated, closed and appeared to be in good condition. The oldest accumulation start date observed on the containers was 12/15/2015.

Picture 34: Waste Pile Building less than 90 days 55-gallon storage area. The oldest accumulation start date observed on the 55-gallon containers 12/21/15. Picture taken by Javier Garcia on 2/22/2016, at 3:23 pm.
